INSPECTION REPORT

For the Property at:
1440 LASS
OTTAWA, ON

Prepared for: GGG GGG
Inspection Date: Tuesday, January 14, 2014
Prepared by: Chris McArthur

Report No. 1008, v.2

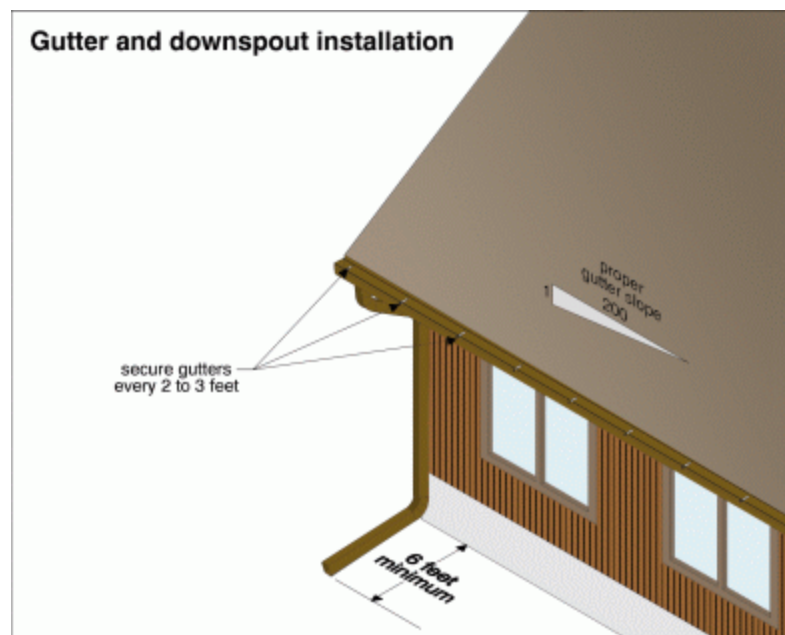
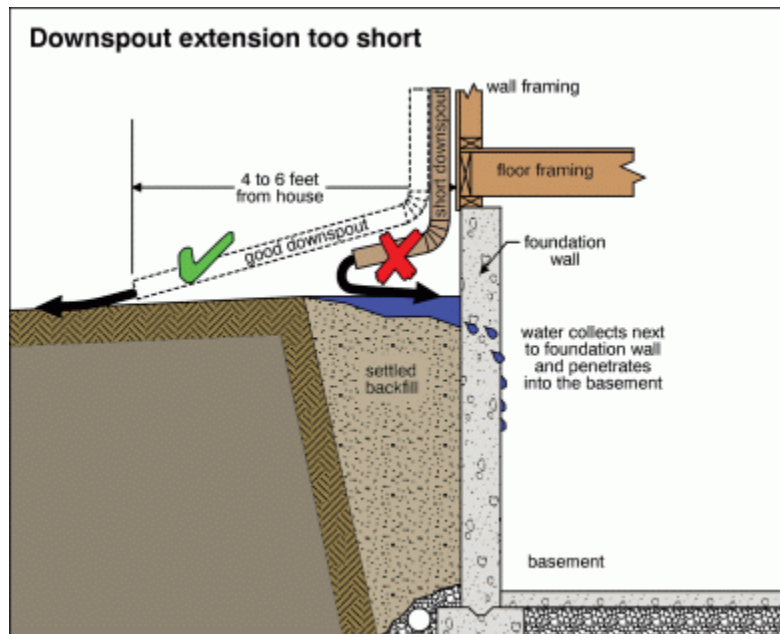
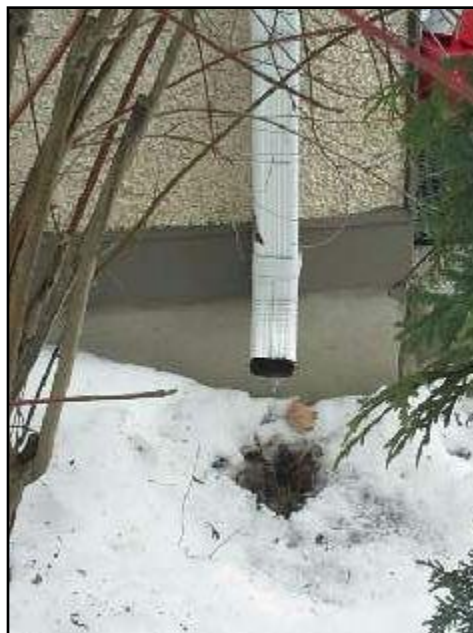
1. Aluminum

1. **Condition:** • Downspouts end too close to building

Downspout discharges next to the structure, which could lead to water infiltration at the foundation level. Recommend extending a minimum of 7 ft.

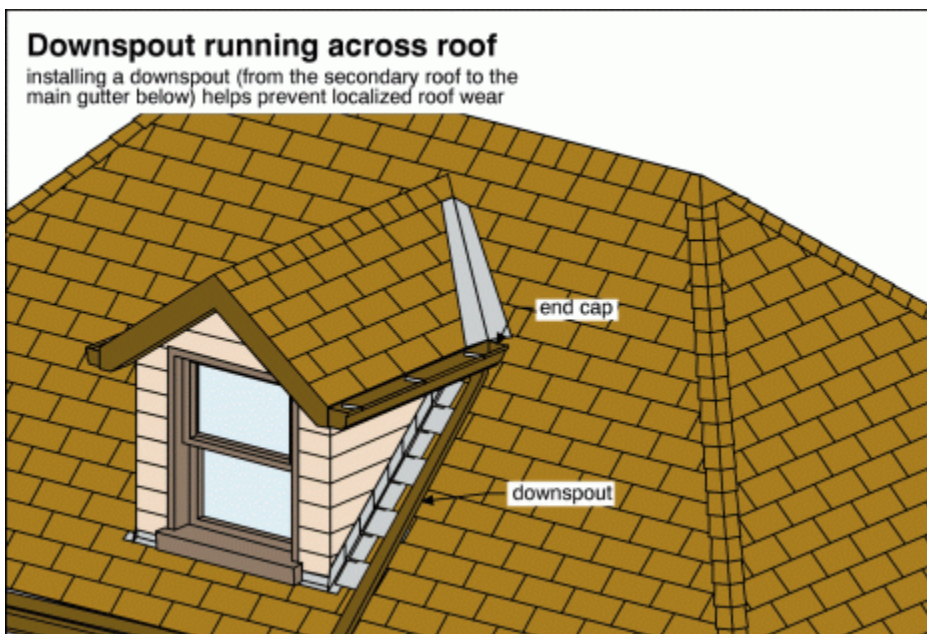
2. Condition: • Downspouts discharging onto roofs

Downspouts should not discharge directly onto roof shingles as it can lead to water infiltration and property damage. Recommend extending the downspout to the lower eave mounted trough.

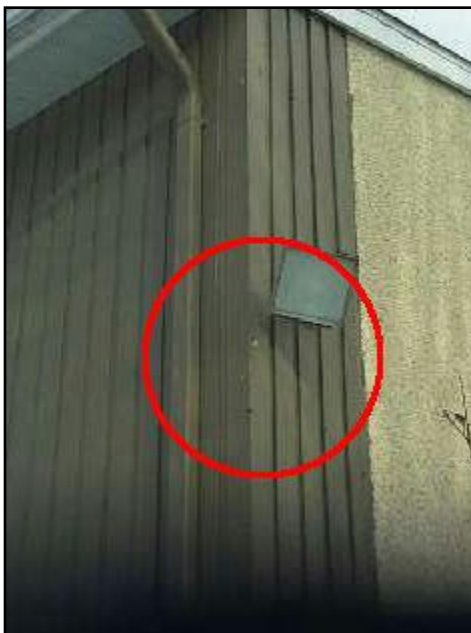
2. Boards

3. Condition: • Woodpecker damage to cedar boards, this could lead to water infiltration. Recommend replacement by professional contractor.

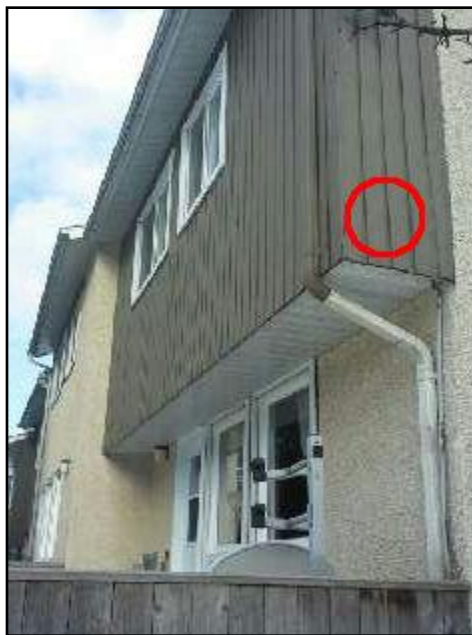
3. Boards

4. Condition: • Cracked, split or broken

The cedar boards are cracked and could lead to water infiltration. Recommend replacement by professional contractor.

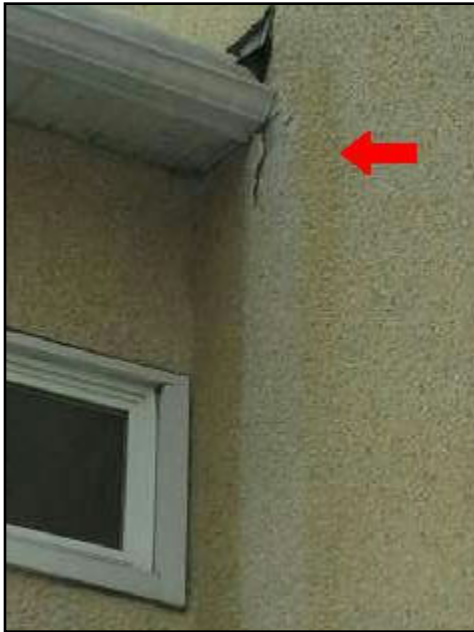
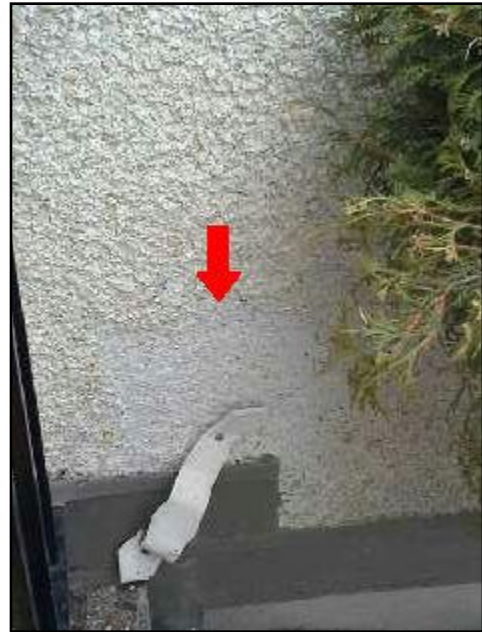
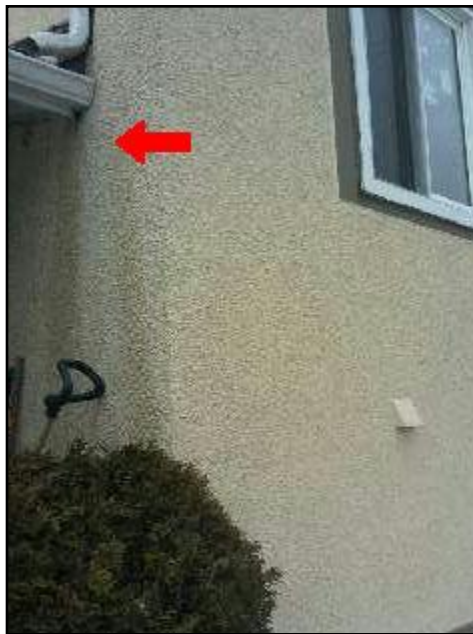
5. Condition: • Mechanical damage

Stucco at the front of the house has been damaged by ice from the eaves trough, this could lead to water infiltration and further property damage. Recommend repair by professional contractor.

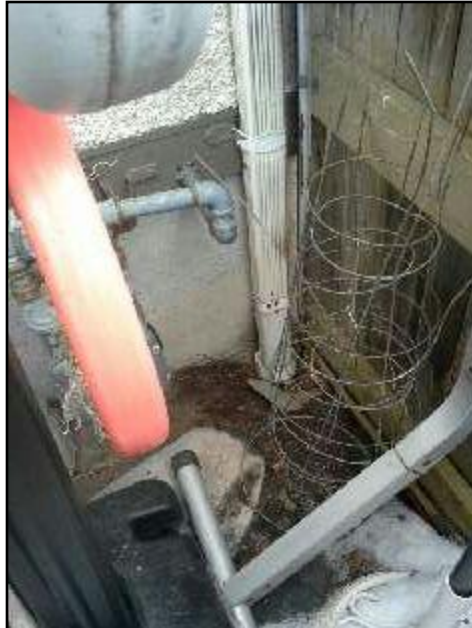
7. Below grade

downspout terminates at ground level in a 3in pvc pipe. Discharge terminus unknown.

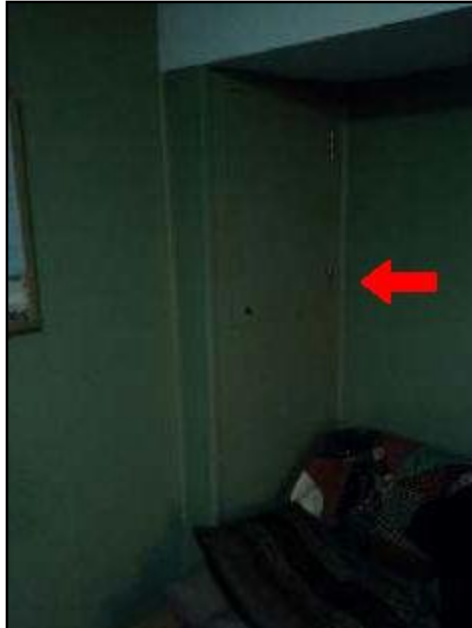
13. Restricted access

Access restricted by couch in front of built in cabinet where the electrical panel is mounted.
